**IRRIGATION WATER
USE ASSESSMENT
REPORT FOR:**

Holland Marsh Growers'
Association

HMGA-02-P01

Enviro-Stewards Inc. conducted an irrigation assessment on a sprinkler system on August 4-5, 2021.

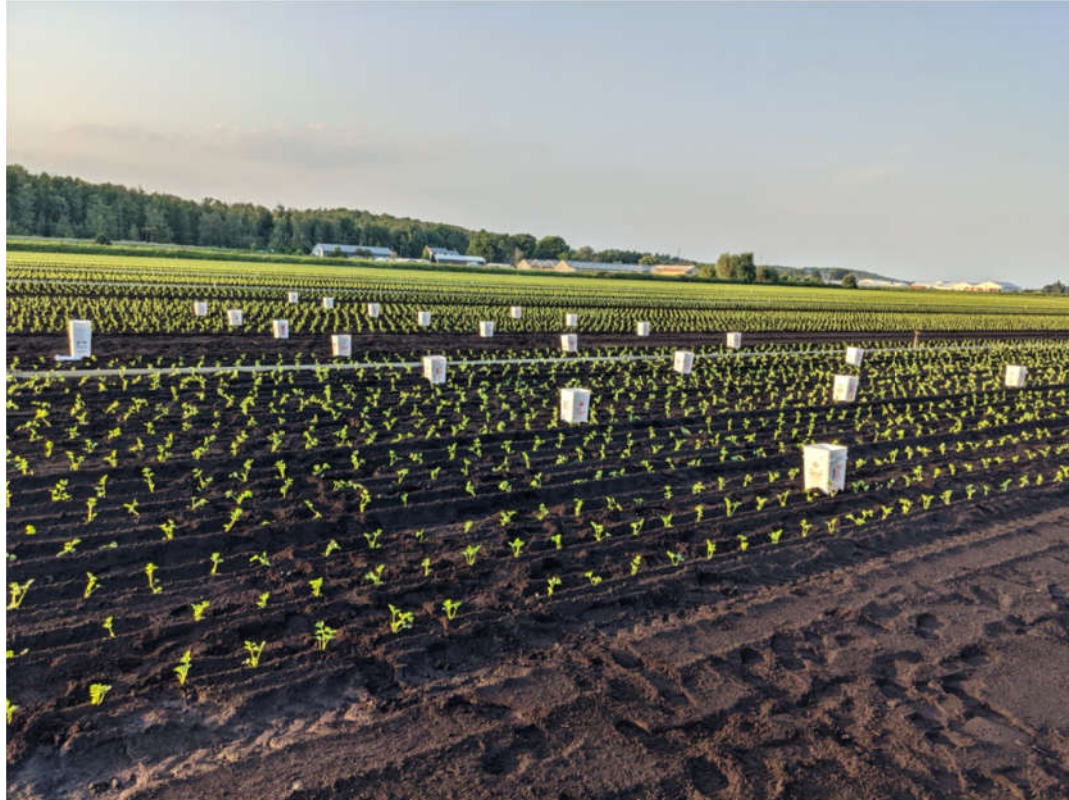
Figure 3: Catch Can Layout.

A total of 24 catch cans were placed in the collection area. Three rows of four cans were spaced 15 feet by 10 feet apart respectively in a grid pattern on either side of the lateral (12 cans to the left of the lateral and 12 to the right). The catch can layout is presented in Figure 3.

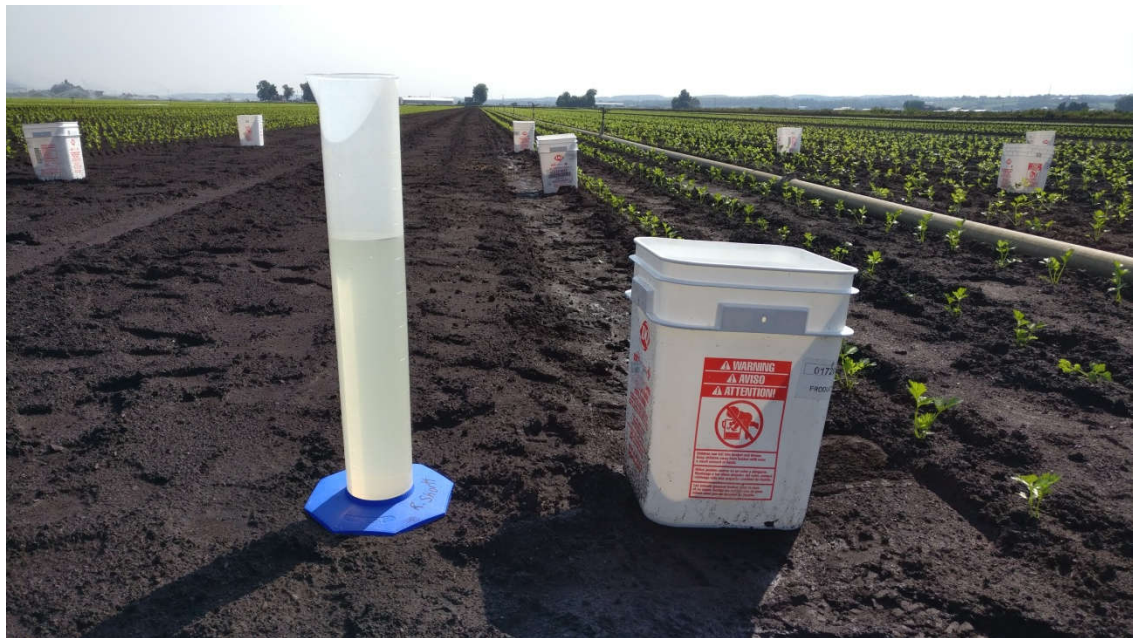
Figure 5: Example of Measuring Catch Can Intercepted Water

The collection grid was set up the night before the system operated. The test area was irrigated from 6 to 8am the next day. The water measurements were taken from 11am to 12pm the same day. An example of measuring the water from a catch can at the end of the test is presented in Figure 5.

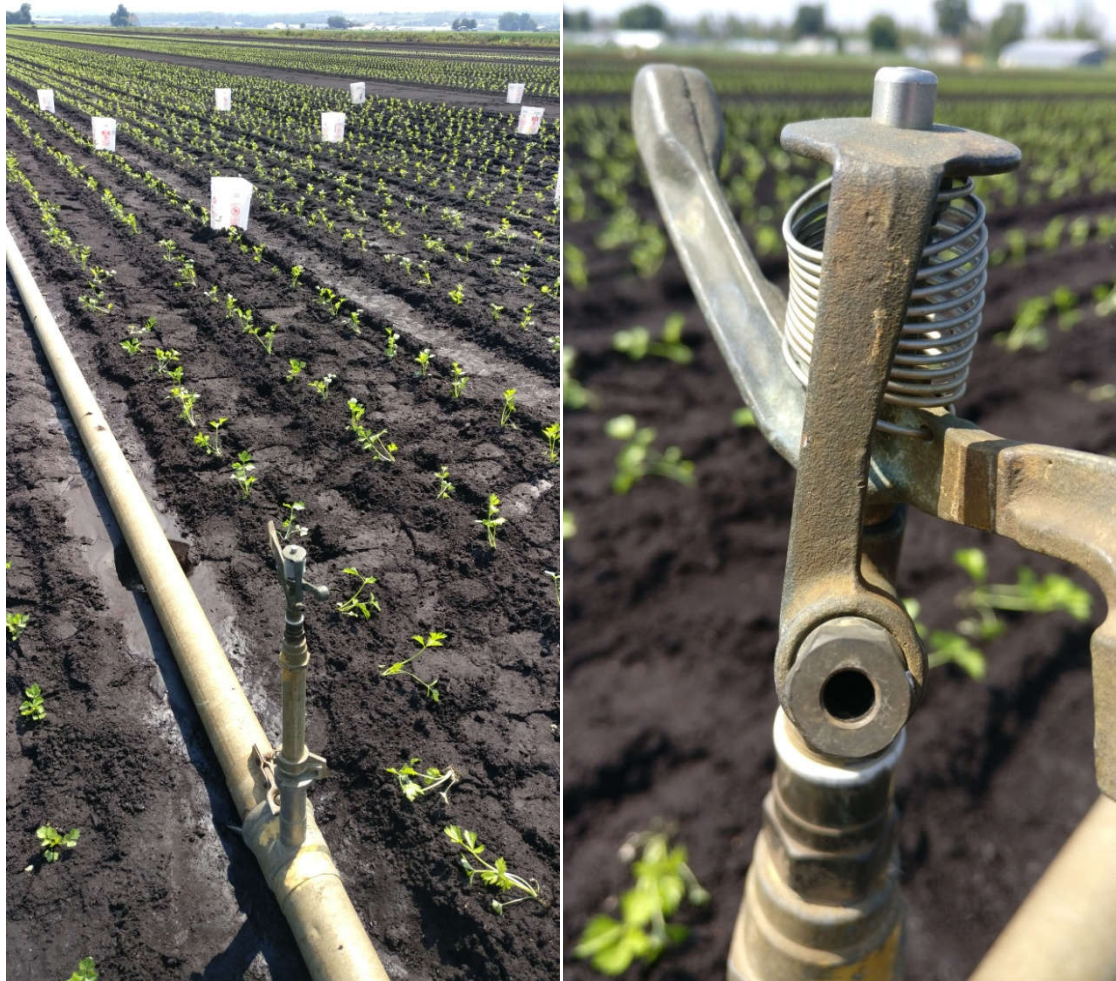
Figure 6: Test Sprinkler Head #7

Pressure and flow measurements were taken at 22 sprinkler heads along a non-test lateral. Flow from each nozzle was measured by timing how long it took to fill a 17.5 litre pail.

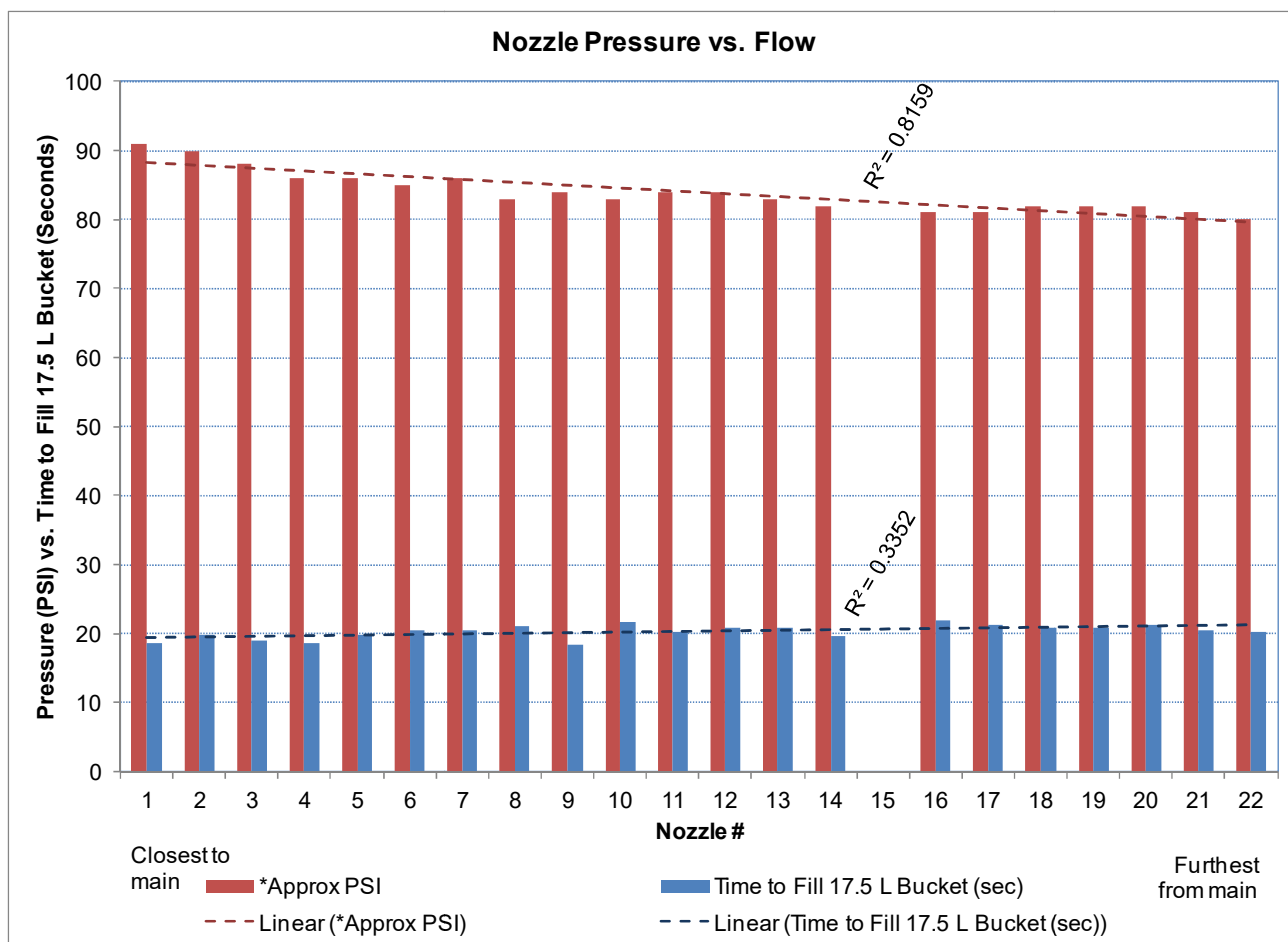
Figure 7: Pressure versus Flow Measurements at Each Nozzle

Figure 7 shows the pressure and flow measurements at each nozzle. Pressure appears to drop along the length of the lateral. Pressure is highest at the nozzles closest to the main and lowest at those furthest from the main. This drop is not considered significant.

Flow does not appear to be related to distance from the main; in fact, it appeared to improve with distance from the header.

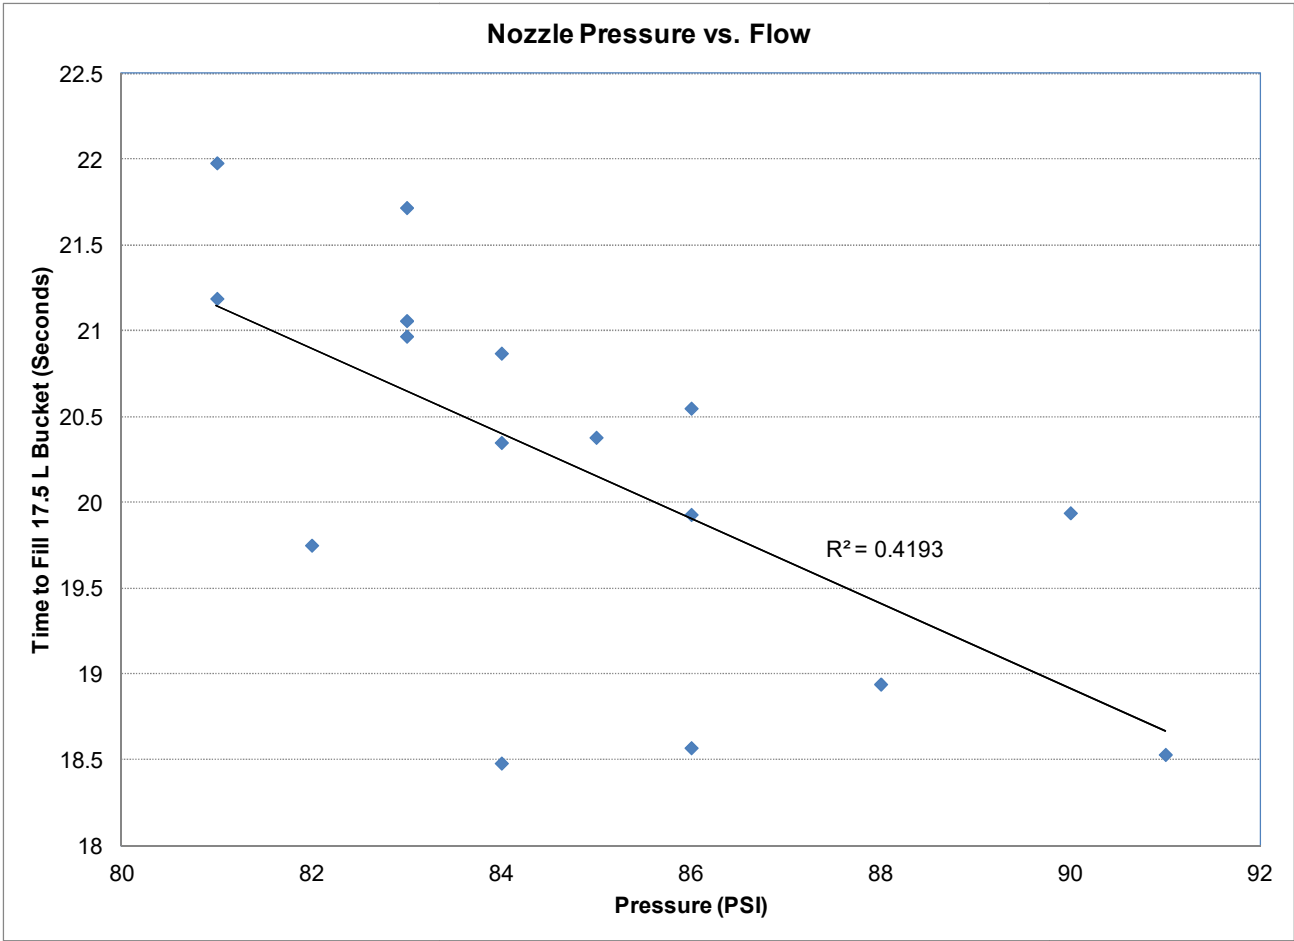
Figure 8: Relationship between Nozzle Pressure & Flow

Figure 8 looks at the relationship between pressure and flow. This relationship is quite weak.

Based on the analyses presented in these two figures, it would seem that flow is not related to distance from the main or to nozzle pressure. Nozzle wear did not appear to be an issue.

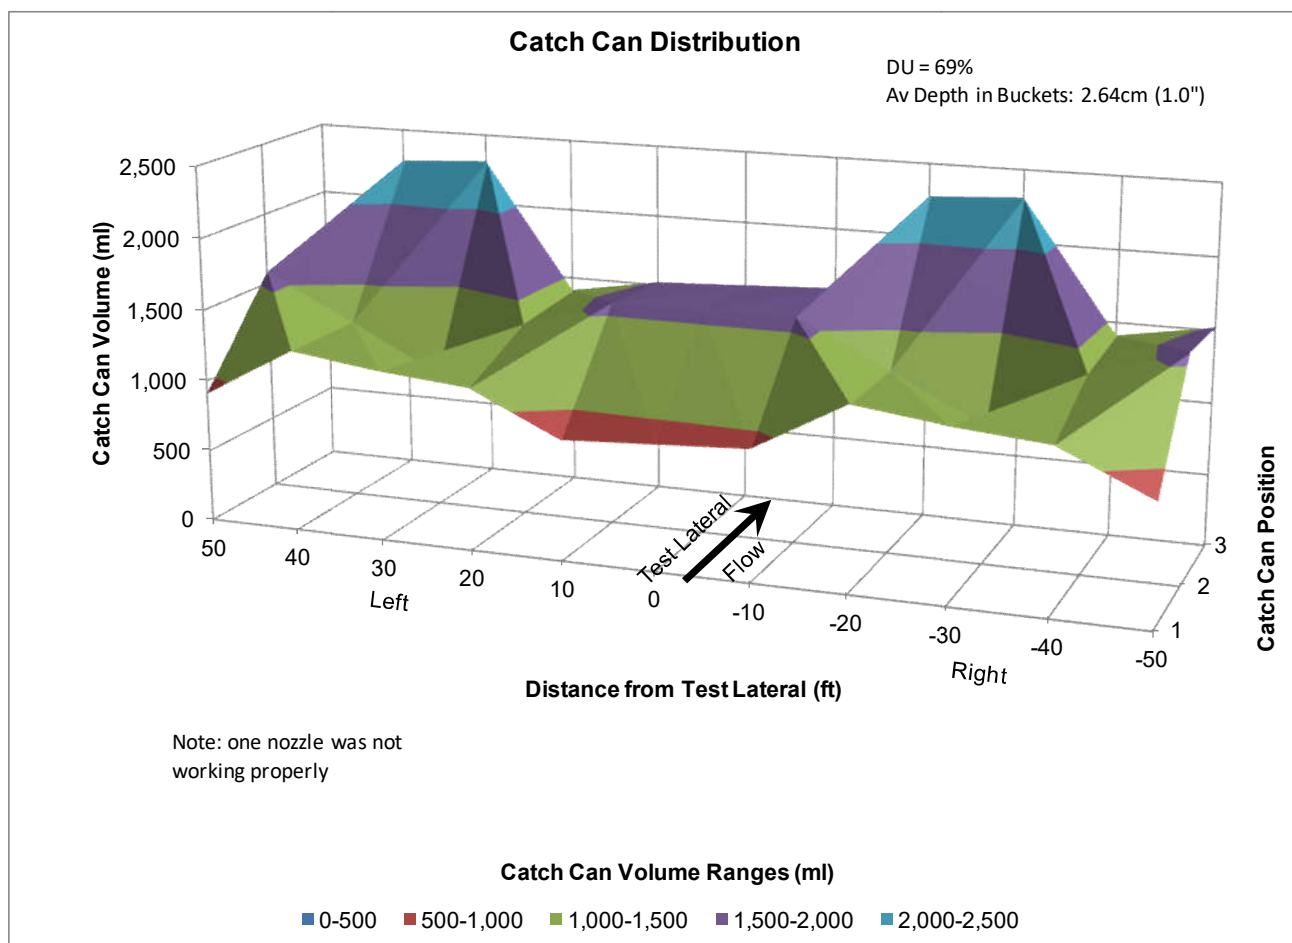
Figure 9: Distribution Uniformity of Current Irrigation System's Water Application

DULq of 69% (0.69) is fair compared to sprinkler evaluations conducted in California. A fair DULq means the uneven distribution will overwater some areas of the field and leave other areas with too little water (Figure 9). It also means that additional water is required to ensure that the driest areas (those with poor or no overlap) receive the desired amount of water. This uneven distribution can affect produce quality, quantity and maturation time.

A nozzle replacement program is in place and should continue in order to help improve the irrigation water application uniformity over the field.

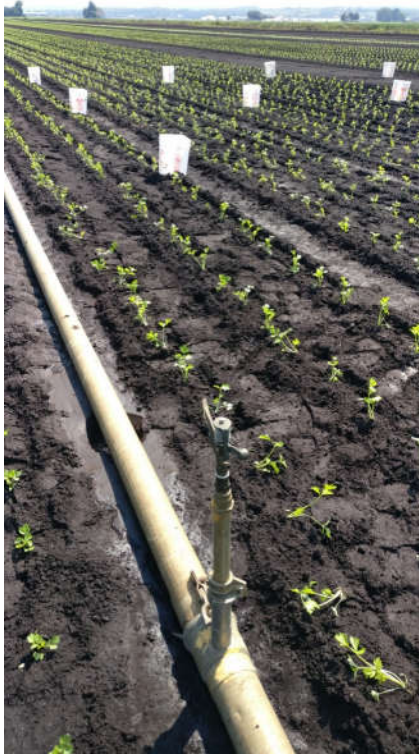
Figure 10: Moist Patch in the Collection Area

Very moist patches were observed in the collection area after the irrigation system was turned off as can be seen in Figure 10.

Some leaks at pipe connections along the lateral and the header were observed and should be repaired.

Repair any leaks as quickly as possible to prevent standing water or runoff from the field.
