VEGETABLE PACKING FACILITY WATER USE ASSESSMENT REPORT FOR:

Holland Marsh Growers' Association

January 28, 2022 HMGA-02-P01

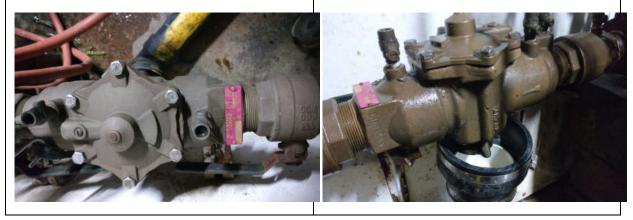
Figure 7: Backflow Preventer Drip Collector

A reduced pressure backflow preventer (BFP) is installed on the water supply to the facility after the meter (Figure 5, Figure 6). The BFP is dripping at a rate of 0.023 lpm based on a timed grab sample. According to facility staff, the BFP leaks 24/7/365. A collection system (Figure 7) directs the dripping water to a floor drain that is connected to the settling tanks before discharging to the municipal sewer system.

- 1. Excessive Pressure on Plant Side of BFP:
 - Directing the plant supply line up to the ceiling of the production area may result in an elevated pressure exceeding the pressure setpoint of the BFP.
- 2. Debris in Relief Valve;
- 3. Relief Valve is Failing;
- 4. Test Cock Leak:
 - a. Valve has failed;
 - b. Debris has damaged ball;
 - c. Plastic casing inside has failed.
- 5. Freeze Protection Device is Worn Out;
- 6. Pressure Relief Valve is Worn Out.

- An inspection of the BFP by a licensed BFP inspector to identify & repair the issue or replace the BFP;
- The BFP should be inspected annually to address any issues that might arise.

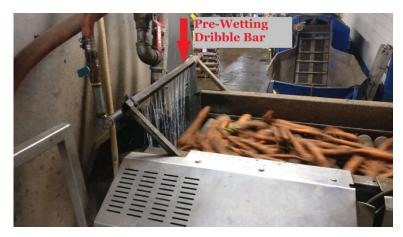
Figure 14: Intake Pre-Wetting Dribble Bar

A dribble bar pre-wets the vegetables as they enter the washer (Figure 14). The dribble bar supplies 8.4 lpm based on a timed grab sample. The excess water is collected in the collection tank for reuse in the washer.

• Replace the dribble bar with a spray nozzle system that delivers 0.7 lpm per nozzle. Based on the length of the current spray bar, one to 2 nozzles should be adequate depending on the mounting height and spray pattern.

• NOTE: If a finger style de-dirter is installed, it is entirely possible that the pre-wetting bar may only be required very rarely or not at all due to improved dirt removal.

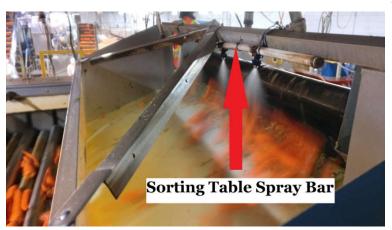
Figure 15: Sorting Table Spray Bar

from the 4 nozzles on the sorting table spray bar (Figure 15) has been assumed due to a data logger failure. Each nozzle is assumed to discharge 1.9 lpm, which is based on a grab sample from a similar type of nozzle at another site.

The excess water from the spray bar (Figure 15) at the intake end of the sorting table is directed to the floor drain.

• Replace the existing spray nozzles with more efficient nozzles that deliver 0.7 lpm per nozzle.

- Pump the sorting table discharge water to the collection tank under the polisher for reuse to wash dirty vegetables entering the washer.
 - It is assumed that more efficient 0.7 lpm spray nozzles have been installed on the spray bar, replacing the existing nozzles.
 - The excess sorting table water is relatively clean, but will need a filter to remove debris such as vegetable tops and roots.
